CHANGING A VITRA PLUTO WC SEAT

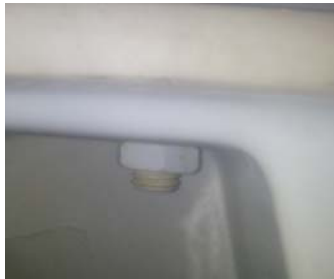
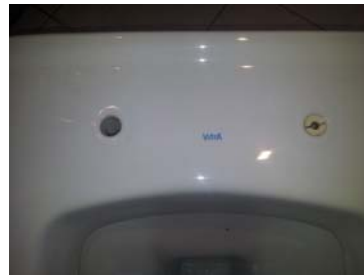
The top left picture shows the original Pluto fixing. This fixing is bolted in place at the time of manufacture. The top right picture shows the view from above.

These fixings are by far the best but when changing my seat the left hand one collapsed during the screw removal because the screw was so badly corroded into the fitting. The pan had to be removed to remove this fitting.

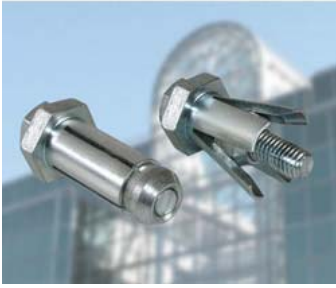
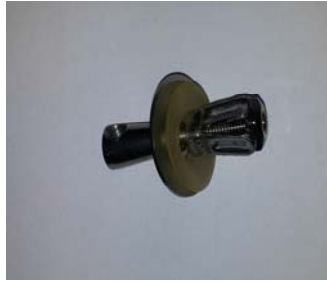
The fixings pictured above all work by forcing out 4 metal wings which are meant to securely grip the sides of the pan holes. As you tighten the screw from above a nut is drawn upwards forcing out the metal wings. In my view metal on porcelain is a bad mix and they were not terribly successful. Again removal can be a problem due to corrosion. Removal if corroded in can prove problematical. Try lifting the fixing upwards whilst unscrewing. If this fails drilling or grinding off the screw head will enable you to knock the fitting downward and into the pan void.

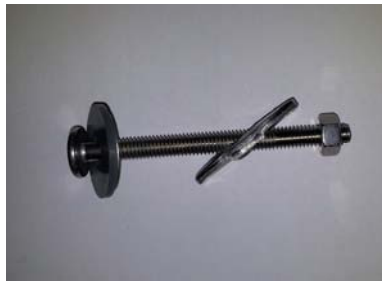
The idea behind this type of fixing is that the bolt containing the central toggle is placed into the hole deep enough to allow the toggle to flip out and during tightening grips the underside of the hole. Sometimes, when not careful during fitting the toggle has not flipped out underneath the hole but is still in the confines of the hole. It will appear that the fitting is working but they will have fouled the threads of the bolt making removal difficult. If fitted correctly one of the failings are there is nothing to position the bolt in the pan hole so it can easily move around loosening the fixing.

To remove this type of fixing you have to apply upward pressure holding the toggle in position on the underside of the pan hole while you unscrew.

Again corrosion can be a problem. Drilling or grinding of the screw head will work.

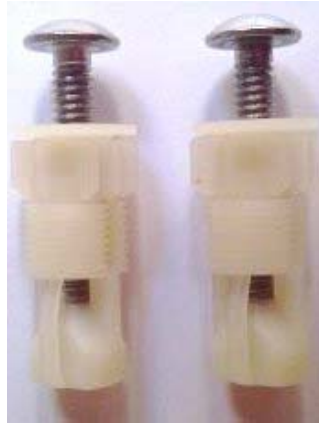
Finally to conclude, it will be very hard to identify the type of fixing you have as all you can see is a bolt or screw head. I have no advice to offer to aid identification sorry. Our seat comes with blind hole fixings as pictured below.

These will work and hold the seat in place. At first they look perfect but are very reliant on the depth of the hole in the pan. On some pans they work well on others not as well as I would like but Blind hole fixings however will continue to be an annoyance and never perfect. A search for **well nuts** will display various rubberised varieties.

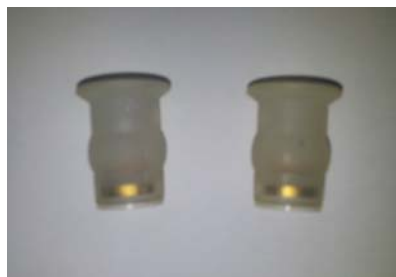
Finally here is the best fixing I have found to date. (Pictured below) They are made by fischer of Germany and used in all Duravit pans. Sorry but nobody seems to sell them so I am currently investigating purchasing myself.

They are fitted by hammering into place. You have to be careful because a false slip and you will have a broken pan so a plastic headed hammer would be safer. The final pictures show the fischer fixing installed on a Pluto pan.

The duravit part code for the fischer fixings is 0050501000.
