CHANGING A VITRA PLUTO WC SEAT

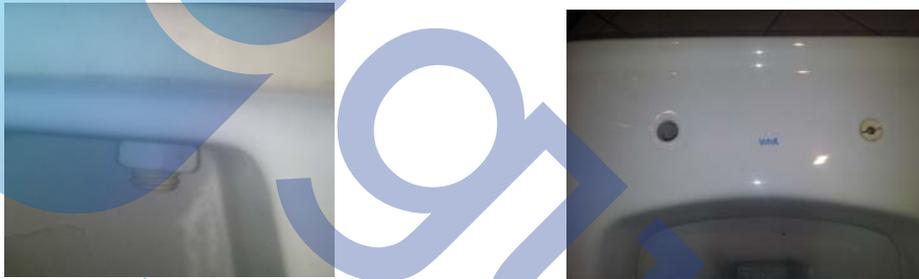
The top left picture shows the original Pluto fixing. This fixing is bolted in place at the time of manufacture. The top right picture shows the view from above.

These fixings are by far the best but when changing my seat the left hand one collapsed during the screw removal because the screw was so badly corroded into the fitting. The pan had to be removed to remove this fitting.

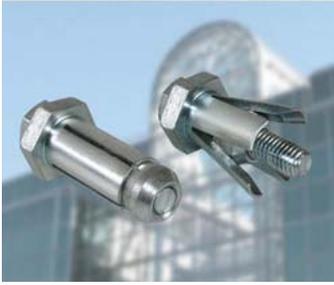
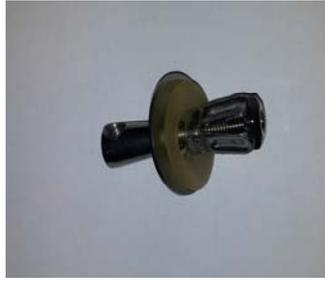
The fixings pictured above all work by forcing out 4 metal wings which are meant to securely grip the sides of the pan holes. As you tighten the screw from above a nut is drawn upwards forcing out the metal wings. In my view metal on porcelain is a bad mix and they were not terribly successful. Again removal can be a problem due to corrosion. Removal if corroded in can prove problematical. Try lifting the fixing upwards whilst unscrewing. If this fails drilling or grinding off the screw head will enable you to knock the fitting downward and into the pan void.

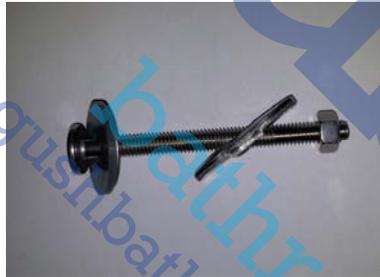
The idea behind this type of fixing is that the bolt containing the central toggle is placed into the hole deep enough to allow the toggle to flip out and during tightening grips the underside of the hole. Sometimes, when not careful during fitting the toggle has not flipped out underneath the hole but is still in the confines of the hole. It will appear that the fitting is working but they will have fouled the threads of the bolt making removal difficult. If fitted correctly one of the failings are there is nothing to position the bolt in the pan hole so it can easily move around loosening the fixing.

To remove this type of fixing you have to apply upward pressure holding the toggle in position on the underside of the pan hole while you unscrew.

Again corrosion can be a problem. Drilling or grinding of the screw head will work.

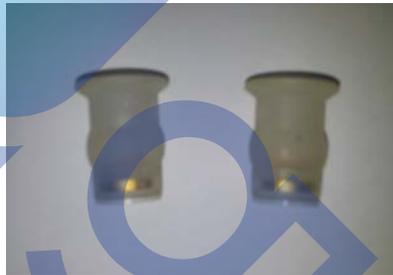
Finally to conclude, it will be very hard to identify the type of fixing you have as all you can see is a bolt or screw head. I have no advice to offer to aid identification sorry. Our seat comes with blind hole fixings as pictured below.

These are by far the best fixings I have found to date and I have located the manufacturer and they are now in stock

They are fitted by hammering into place. Lubricating the plug with washing up liquid or similar will help ease the plug into place. You have to be careful because a false slip and you will have a broken pan so a plastic headed hammer would be safer. If you don't have one of these then a block of wood will suffice. The final pictures show the fixing installed on a Pluto pan.
